## Mechanical Testing Report

Report Number: WS154334 February 7, 2022  
Client: UNI-PIER AUSTRALIA PTY LTD Page 1 of 4  
188 Silverwater Road, NSW 2128  
Client Contact: Kerry Bennett  
Order Number: UP190321  
Test Requirement: Apply a compression load to screw top head assemblies till destruction as per Client instructions  
Sample Identification: 154334 A: Six 5mm x 65mm x 65mm x 2mm screw top head assemblies  
154334 B: Six 5mm x 75mm x 75mm x 2.5mm screw top head assemblies  
Sample: Twelve screw top head assemblies (refer photograph on page 2)  
Test Conditions: Ambient temperature 22°C Date/s of test: 7/02/2022

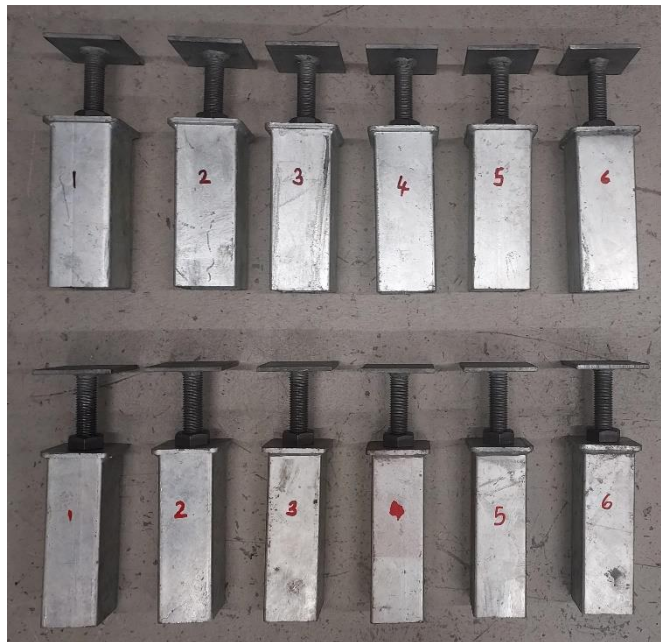
Sample B

Sample A

Sample as received

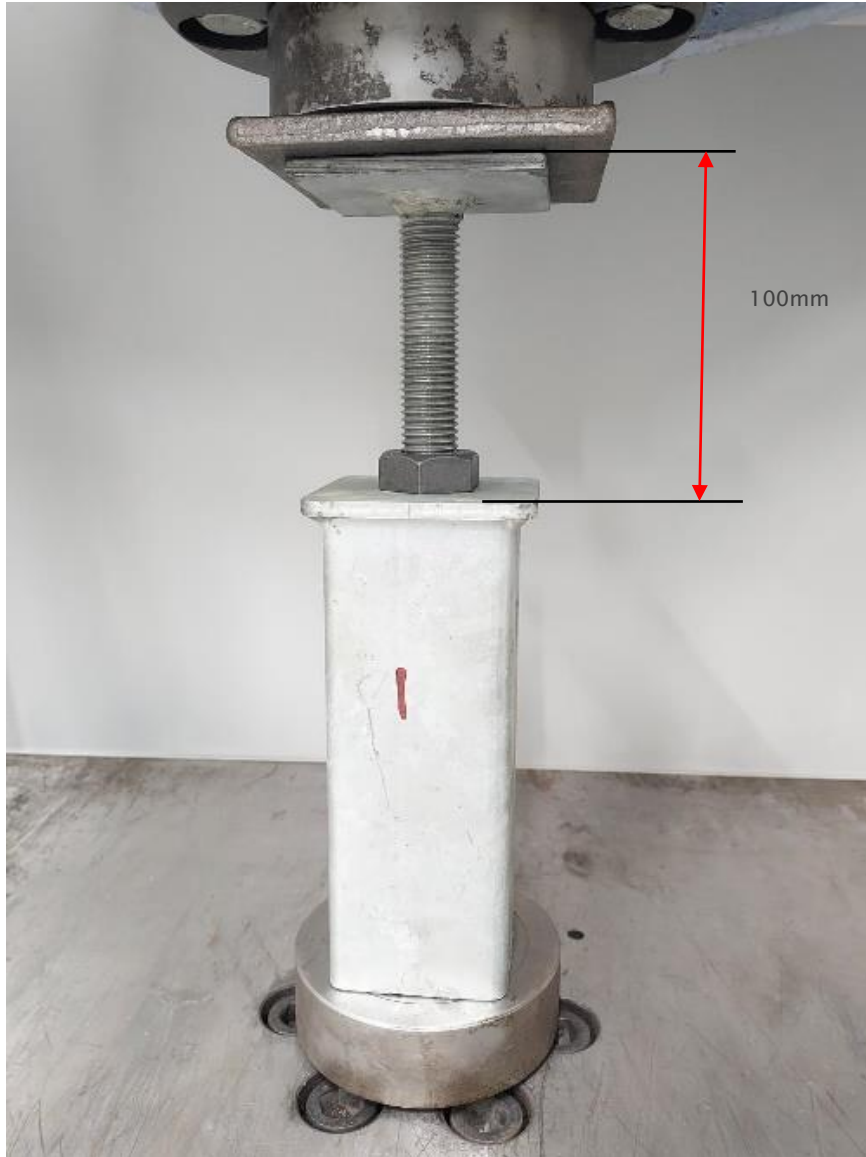
Test set up

- Screw top head assemblies were subjected to a compression load till destruction. (Refer photograph on pages 3 and 4).
- Each assembly was visually examined, and the results were recorded in the table 1 below.

**Test Machined used:** Shimadzu 500kN universal tensile testing machine, current calibration certificate no: N2221-X-6.

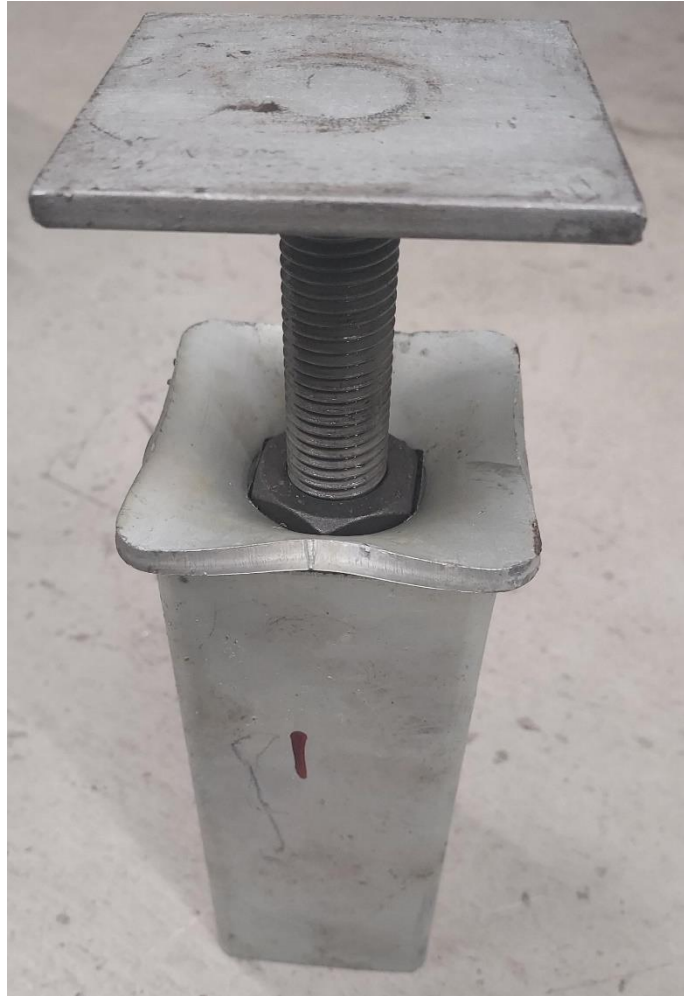
Typical post-test sample

Job No: (Size: 5mm x 65mm x 65mm x 2mm)	Maximum Load (kN)	Observations
154334 A - 1	84.0	Buckling of RHS and top plate attached to it.
154334 A - 2	81.7	Buckling of RHS and top plate attached to it.
154334 A - 3	80.9	Buckling of RHS and top plate attached to it.
154334 A - 4	81.3	Buckling of RHS and top plate attached to it.
154334 A - 5	85.5	Buckling of RHS and top plate attached to it.
154334 A - 6	83.2	Buckling of RHS and top plate attached to it.

Job No: (Size: 5mm x 75mm x 75mm x 2.5mm)	Maximum Load (kN)	Observations
154334 B - 1	94.8	Buckling of RHS and top plate attached to it.
154334 B - 2	94.1	Buckling of RHS and top plate attached to it.
154334 B - 3	91.6	Buckling of RHS and top plate attached to it.
154334 B - 4	94.0	Buckling of RHS and top plate attached to it.
154334 B - 5	94.3	Buckling of RHS and top plate attached to it.
154334 B - 6	97.1	Buckling of RHS and top plate attached to it.
